Recent flash floods and landslides in northern mountainous Vietnam: quick assessment and response measures

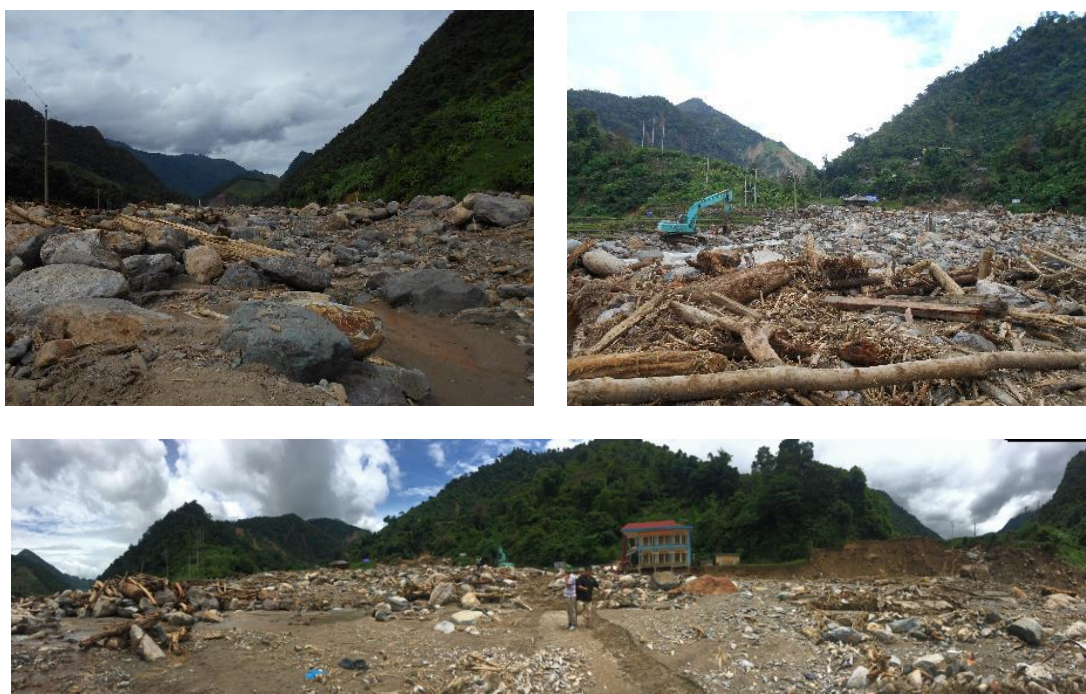
- Flood discharge of the NamPam river far exceeded the capacity of the original river channel, with high concentration of debris contained in the water (debris flow) (Figure 2).
- The river channel expanded from the original width and flood water flew almost over the whole valley bottom.
- The debris flow eroded the river bed and hillsides on both sides of the valley. The flow also deposited vast amount of sand and rocks on the valley bottom.
- The source of the sand and rocks was provided from the hillside collapse and the erosion of river bed and the hillsides.
- The rough estimation of the total volume of sediment provided was several hundred thousand to over a million cubic meters.
- Many houses and buildings were washed away due to the erosion of land or by the force of high-velocity flowing water, and destroyed by the collision of rocks. (Figure 3).

Figure 2. Flood water flew almost over the whole valley bottom. The valley was covered by sand, rock and drift wood.

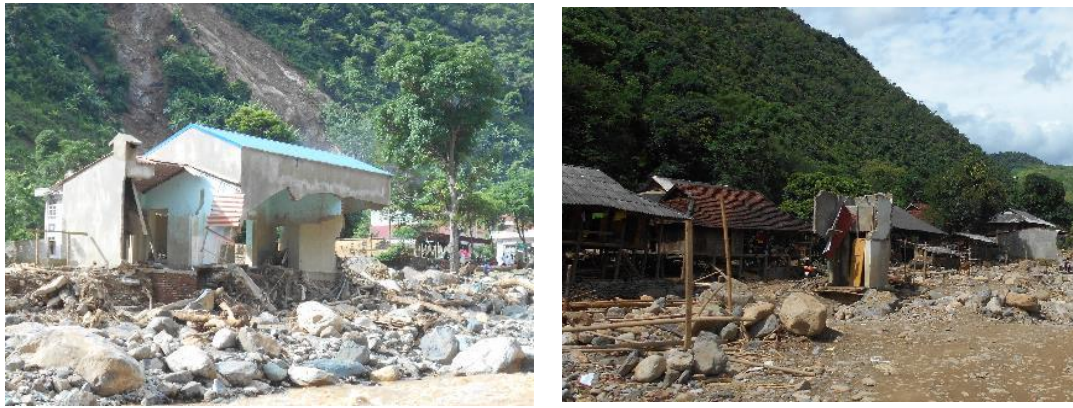
Figure 3. Many houses and building were swept away or destroyed.

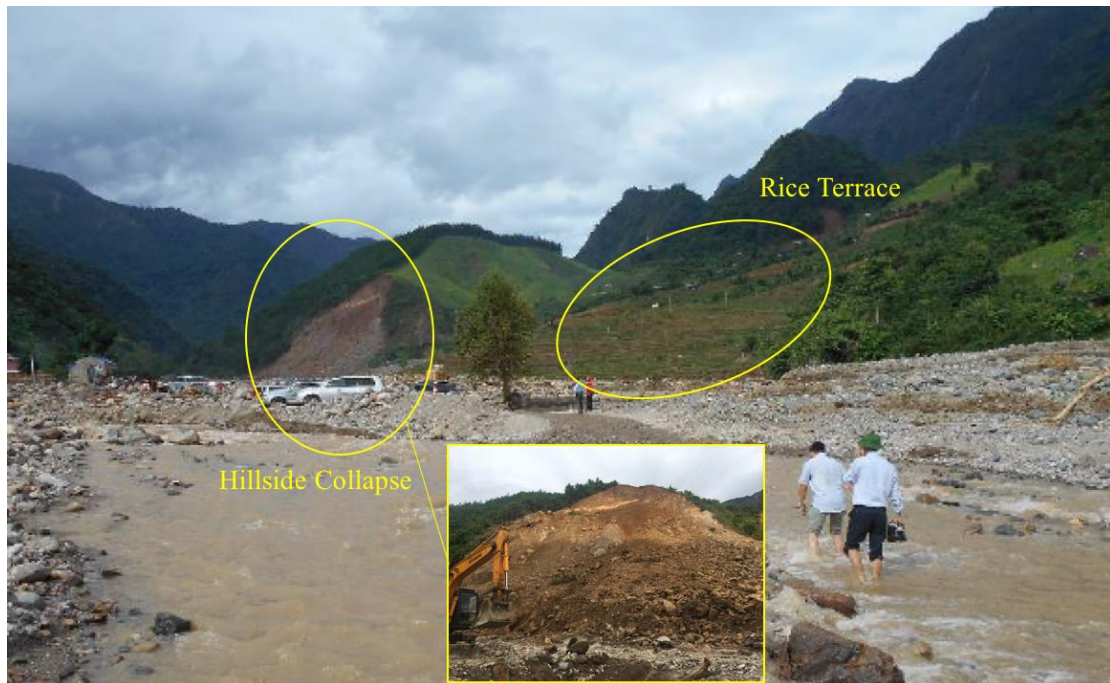
Figure 4. Hillside collapse and rice terrace (deposit of landslide).

It is evident that the valley was recurrently hit by landslide and debris flow. People have been using the land formed by the deposit of sand and rocks formed by landslide or hillside collapse as rice terrace (Figure 4). People have been building houses on the deposit of sand and rocks caused by debris flow in the past.

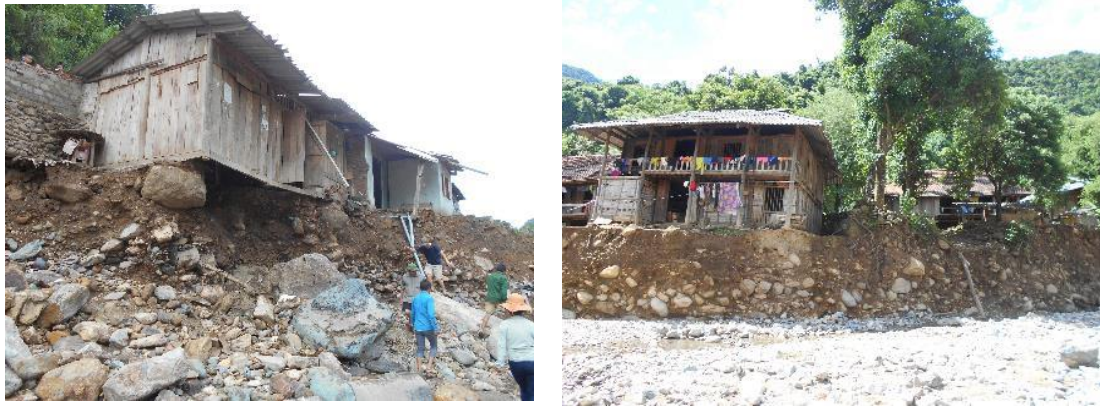
Figure 5. The land below damaged houses and land exposed by side erosion contains big rocks.

This can be seen from looking at the land below the houses that were washed away, or the land exposed by the side erosion (Figure 5). The land contains many big rocks. It means the potential of the damage caused by debris flow is very high in the valley. However, the scale of the debris flow which occurred this time was extraordinary large.
